Technical Report SL-94-24
November 1994

Shear Reinforcement in Deep Slabs

by Stanley C. Woodson

Final report

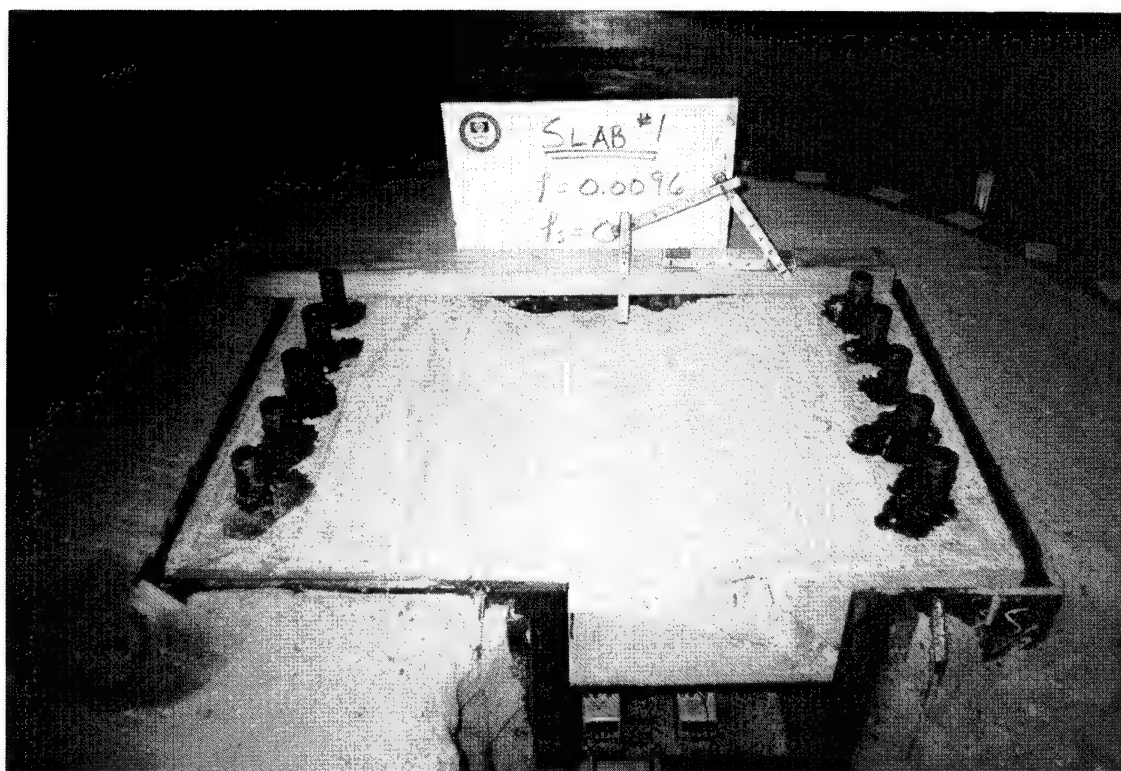
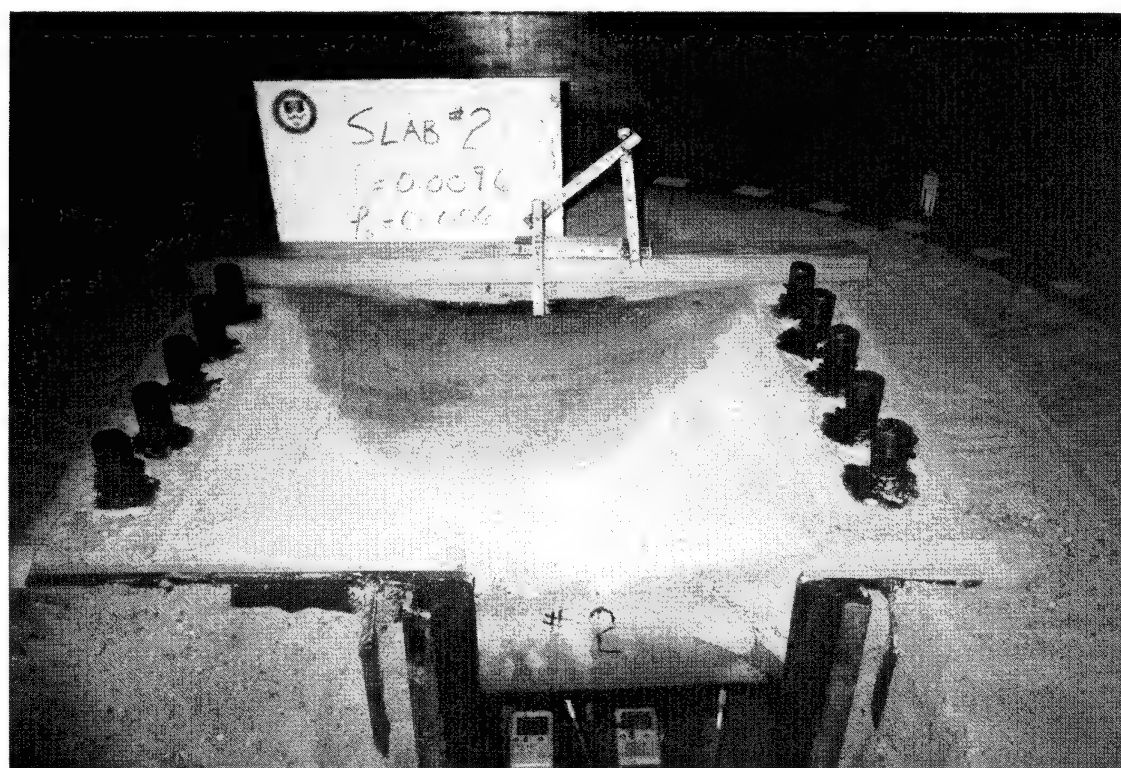
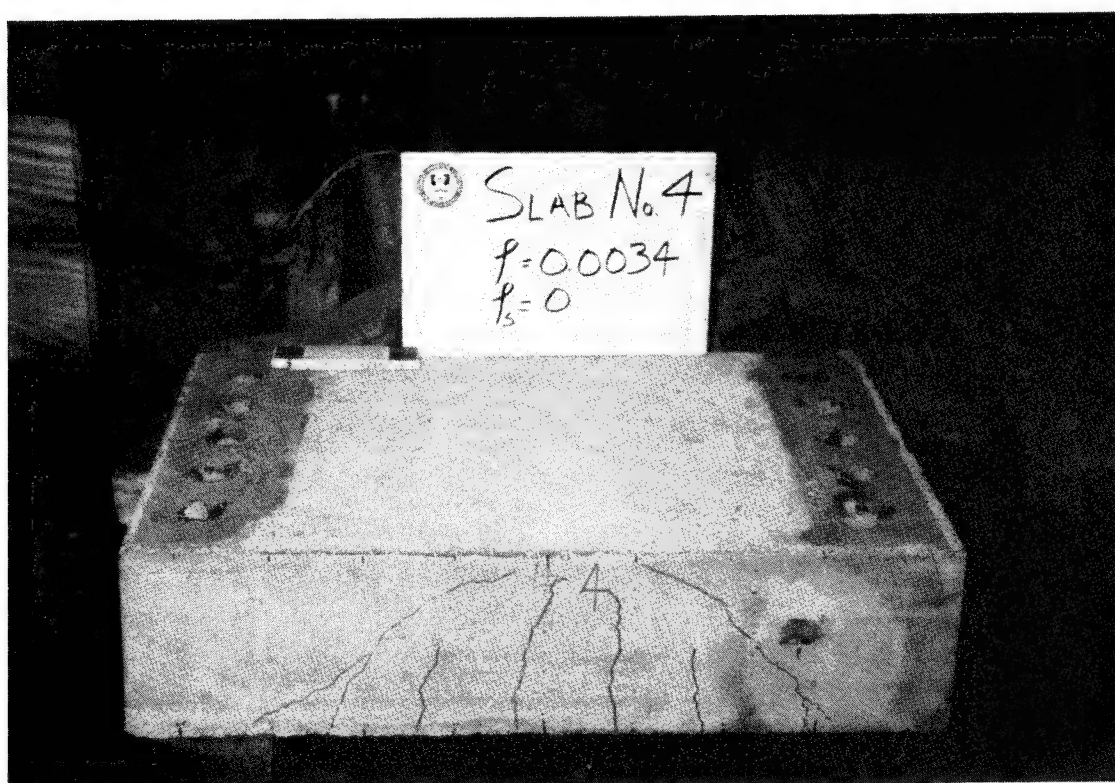
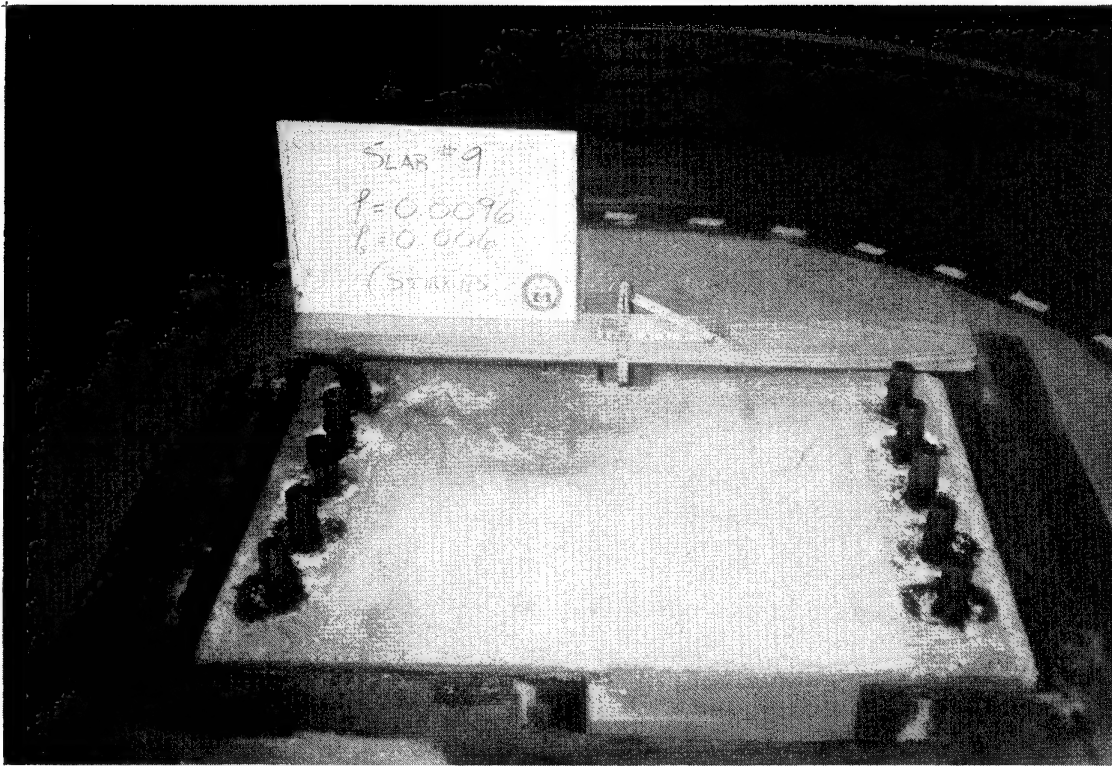
Figure 38. Posttest View of Slab No. 1

Figure 39. Posttest View of Slab No. 2

Figure 40. Posttest View of Slab No. 3

Figure 41. Posttest View of Slab No. 4

Figure 42. Posttest View of Slab No. 5

Figure 43. Posttest View of Slab No. 6

Figure 44. Posttest View of Slab No. 7

Figure 45. Posttest View of Slab No. 8

Figure 46. Posttest View of Slab No. 9

Figure 47. Posttest View of Slab No. 10

Figure 48. Posttest View of Slab No. 11

Figure 49. Posttest View of Slab No. 12

Figure 50. Posttest View of Slab No. 13

Posttest measurements and inspection provided a data check and damage assessment of each slab prior to removal from the reaction structure. Figures 38 through 50 show the posttest condition of each slab. Except for slab no. 4, Figures 38 through 50 show the slab immediately after removal of the neoprene membrane. For slab no. 4, Figure 41 shows the slab after removal from the reaction structure. Slab no. 4 was only slightly damaged and, therefore, could be safely removed from the reaction structure prior to photography. Figure 41 provides a better view of the side crack pattern than was allowed while the slab remained in the reaction structure.

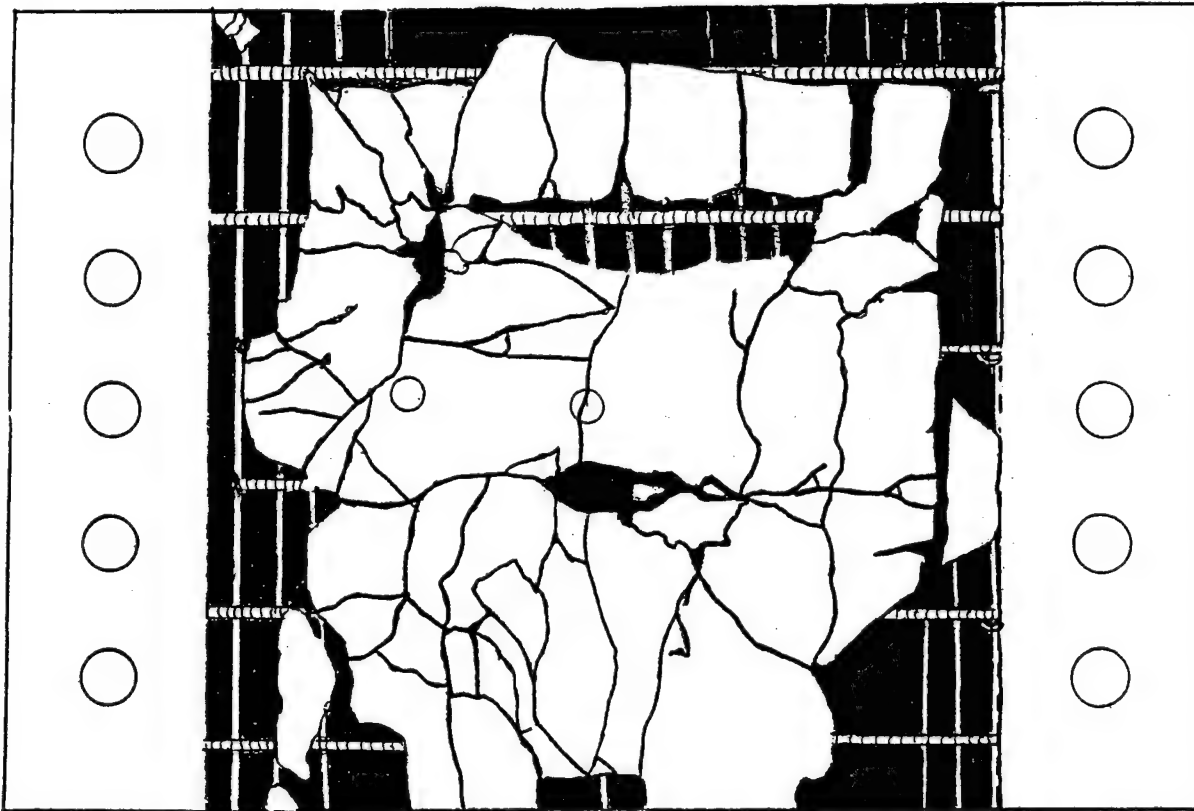
Figure 79. Sketch of Damage for Slab No. 12

Figures 70 through 80 are artist sketches of the bottom and side posttest views of the slabs. Sketches are not included for slabs no. 7 and 11 since they were damaged too heavily for a meaningful drawing. Figures 60 through 80 are useful for the reader that wants to carefully evaluate the response of the slabs. In this report, the figures will not be discussed in detail, but rather are used to support the observations and conclusions drawn from the instrumentation data and damage photographs.

Examination of Figures 60 through 80 indicate that shear behavior generally dominated the response of the slabs. This observation is also evident from a comparison of the midspan and quarter-span load-deflection summaries given in Tables 3 and 4. Since the electronically-measured deflections were similar at quarter-span and midspan, it appears that shear behavior dominated the response rather than flexure which would have produced a deflection profile more representative of a 3-hinge mechanism.
